Re: Submittal of Oversight Report, H.O.D. Landfill, Antioch, Illinois.

**REMEDIAL ACTION OVERSIGHT
H.O.D. LANDFILL
ANTIOCH, ILLINOIS**

NOVEMBER 2001

**Remedial Construction Oversight
H. O. D. Landfill,
Antioch, Illinois**

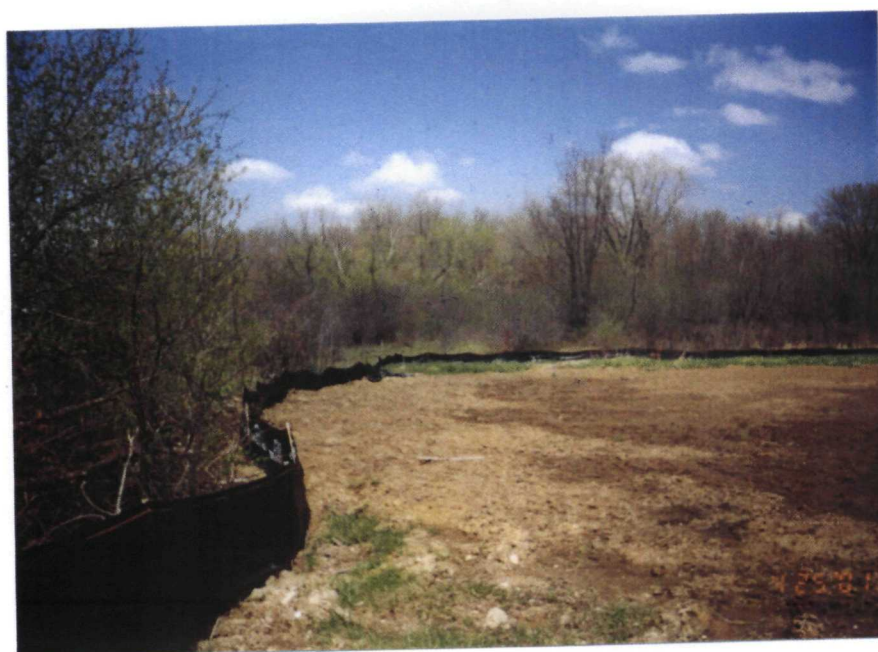
25 April 2001 — Silt Fence at Northwest Corner of Landfill

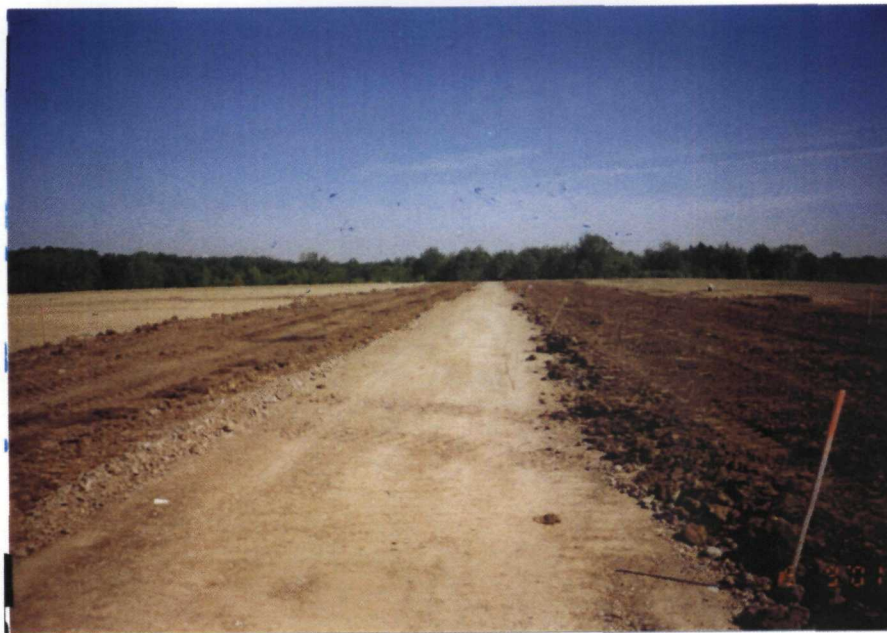
9 May 2001 — Uncompleted Section of Roadway on East Side of Landfill

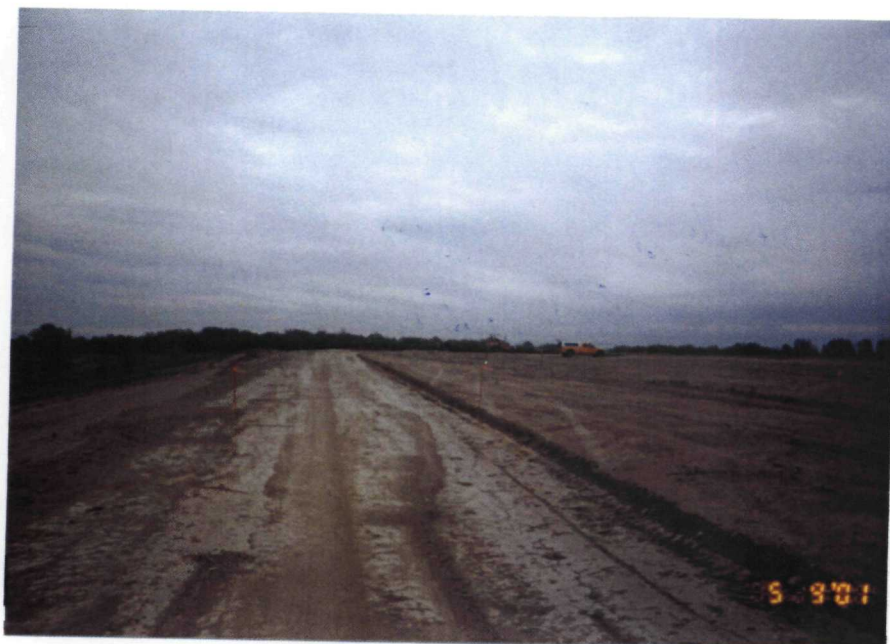
9 May 2001 — Roadway on North Side of Landfill Prior to Gravel Placement

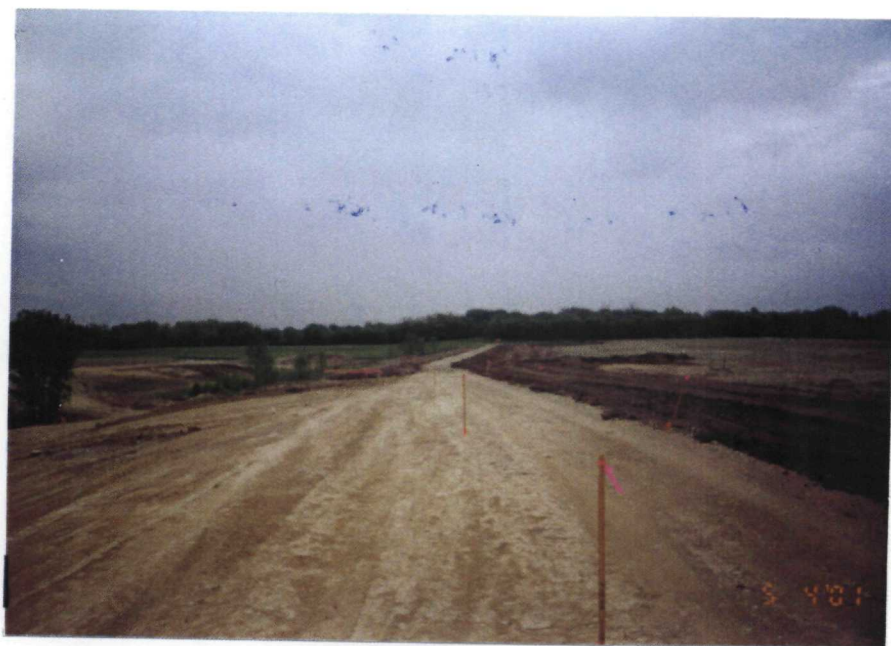
4 May 2001 — Unfinished Section of Roadway on North Side of Landfill
